**Marine Survey Report For Sample Survey**  
**"2005 Viking Sport Cruisers 70 M/Y"**

# 18-290 2005 Viking Sport Cruisers 70 M/Y

The survey was made at the request of the named client Sample Survey for his/her account, in order to ascertain the vessel's general condition and valuation for pre-purchase consideration.

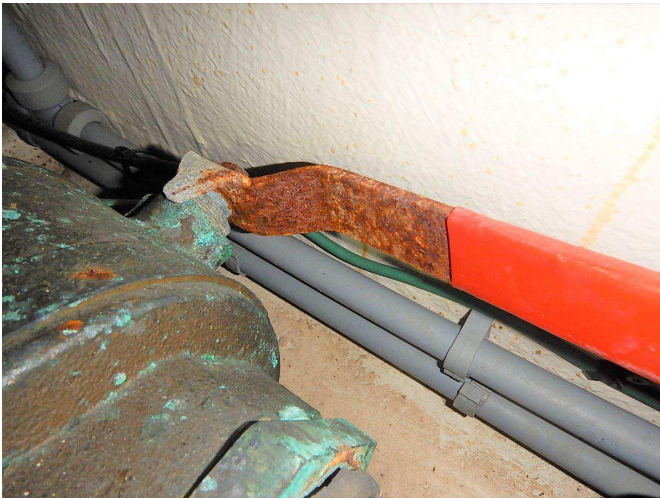
Sea valves for the raw water engine intake were stiff and unable to operate. The starboard engine valve handle is excessively corroded.

Lubricate, service and exercise all sea valves to enable ease of operation. Replace the starboard raw water intake valve handle.

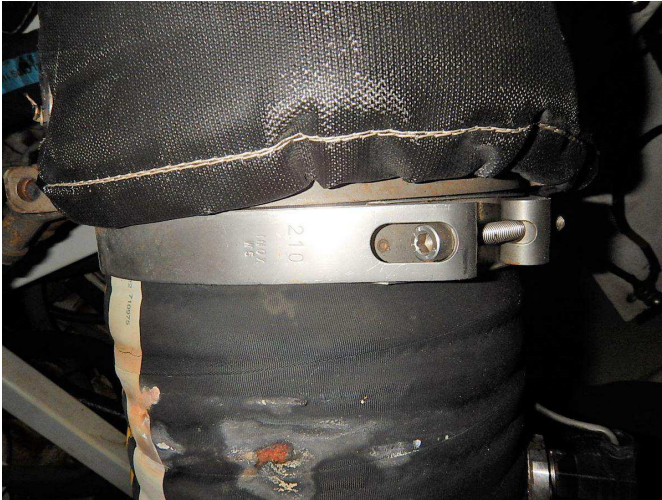
### **FINDING A-4** SHAFTING & PROPELLER(S)

Corrosion was sighted on some of the hose clamps on the port side shaft log.

Replace corroded hose clamps.

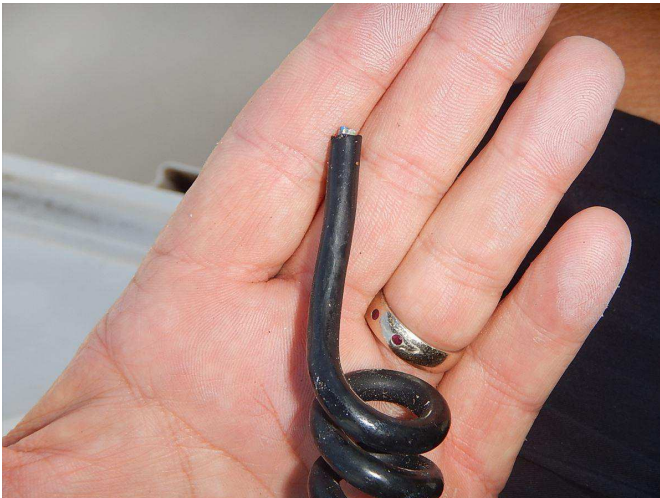
### **FINDING B-14** WASHER/DRYER

The dryer was emitting a sound consistent with a fault alarm of some sort. We were unable to get the dryer to function, power was active to the unit.

Investigate further and take corrective action to repair as required to make functional.
