**Marine Survey Report For Sample Survey**  
**"2005 Viking Sport Cruisers 70 M/Y"**

# 18-290 2005 Viking Sport Cruisers 70 M/Y

The survey was made at the request of the named client Sample Survey for his/her account, in order to ascertain the vessel's general condition and valuation for pre-purchase consideration.

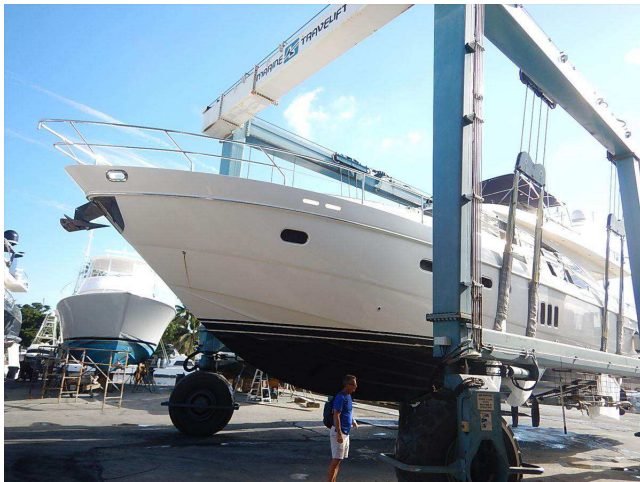
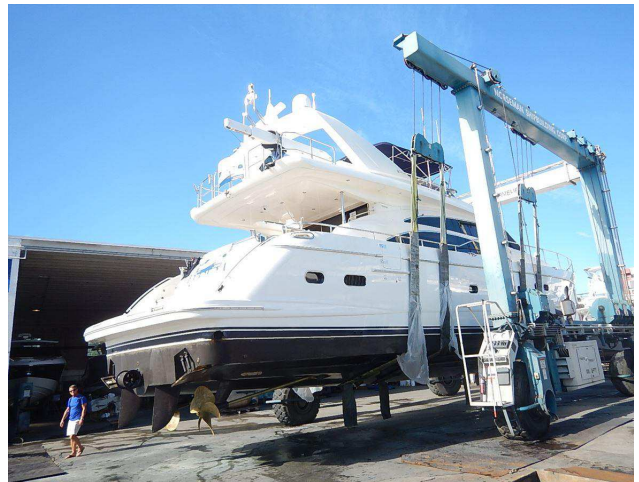
### TRANSOM

Well secured, no cracks or defects sighted. Moisture readings were relatively Dry. No delamination when checked with a percussion hammer.

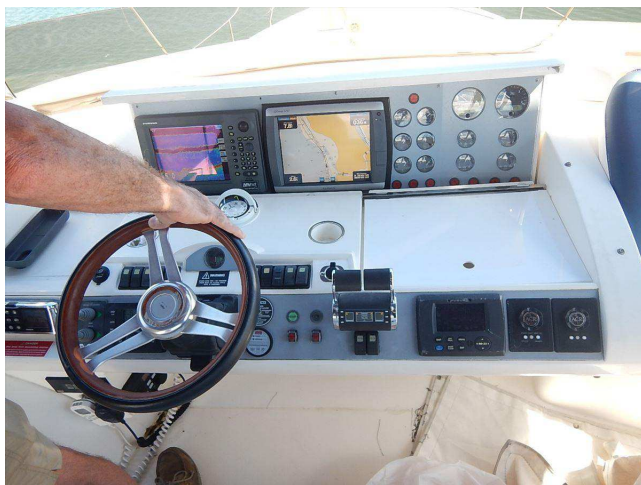
**FINDING B-7**

Electronics mounted on cockpit bulkhead. A 4" Richie compass in serviceable condition. The accuracy of the compass was not verified. An ICOM M-602 VHF radio, powered up and received transmission using the weather service. Received transmission when tested using the Sea Tow automated service. A Garmin GPSmap 5212 chart plotter with navigational charts that was operational. A Furuno NAVnet vx2 with electronic charts, radar and sonar that was operational. A Furuno RD-33 depth finder. SIMRAD AP26 A Raymarine ST6002 smart pilot autohelm system that was proven operational during the sea trial. See Findings & Recommendations.

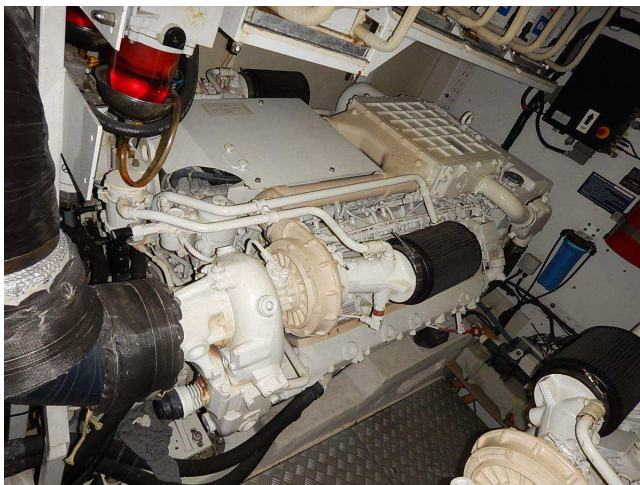
**FINDING A-3**

Sea valves for the raw water engine intake were stiff and unable to operate. The starboard engine valve handle is excessively corroded.

Lubricate, service and exercise all sea valves to enable ease of operation. Replace the starboard raw water intake valve handle.

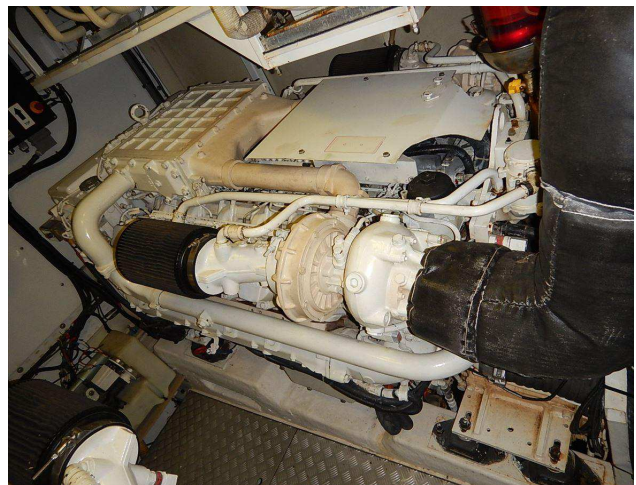
**FINDING B-12**

Two MAN model 1360 in-line twelve-cylinder diesel engines with raw water cooled closed loop cooling system and wet type of exhaust with 1341 SAE rated horsepower. The engines were secured to the vessels longitudinal main stringers made fast by stainless steel engine mount fasteners. No drip pads available, fluid and the debris fall into the bilge area beneath the engines. The engines cooling systems were equipped with engine mounted heat exchangers, engine mounted raw water cooling pumps, engine mounted closed system circulating pumps, remotely mounted closed system expansion bottles and pipe with reinforced hard wall marine water hoses secured with hose clamps, engine mounted OEM type cooling system hoses secured with hose clamps and metal piping. Bronze raw water strainers with site glass were incorporated into the raw water intake hoses, and the raw water was discharged to the exhaust at the mixing elbows. The exhaust systems were wet type with approved high-temperature silicon wet exhaust hose sections, common approved type wet exhaust hoses, metal exhaust tubing and discharged to the aft stern quarters through FRP exhaust tubing laminated into the hull. All sighted exhaust hose connections were not made fast with double hose clamps per ABYC recommendations. All hoses appear to be in serviceable condition. Belt condition appears to be serviceable with no cracks or evidence of belt dust sighted. All fluid levels appeared to be full. See Findings & Recommendations.

As stated in the Terms and Conditions agreement, It is understood that the attending surveyor is not an engine/transmission surveyor. As such, I recommend that all engines and transmissions be inspected by a qualified expert engine surveyor/mechanic to determine the internal condition and any repairs necessary of the engine(s), transmission gears, and pumps, heat exchangers, coolers, etc.

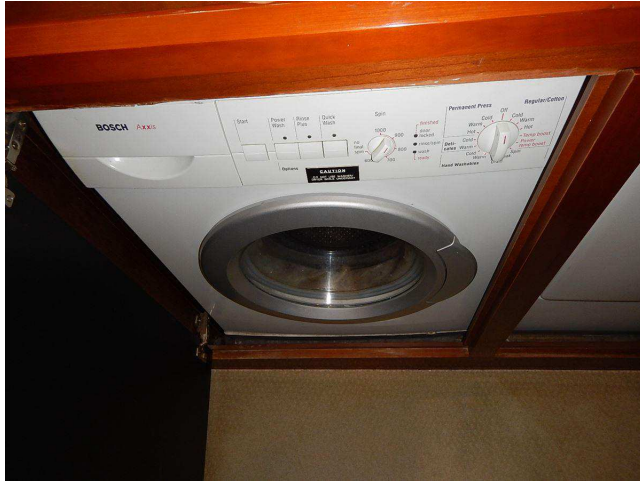
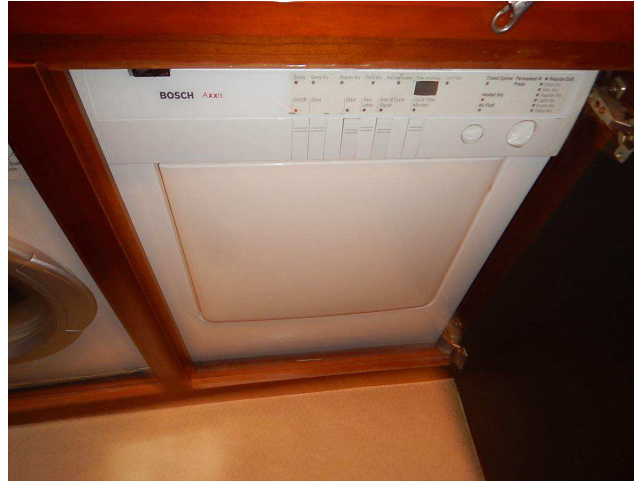
**FINDING B-14**

Bosh Axis washing machine and dryer located just forward of the Master Stateroom. The washing machine powered on and started a cycle but due to not fresh water pump was not tested past a few seconds. See Findings & Recommendations
